Lessons Learned from the Abandonment of the Knarr and Gaupe fields

Lars Endre Hestenes
GM Wells Operations
PTE - Well Completions & HWU/Snubbing

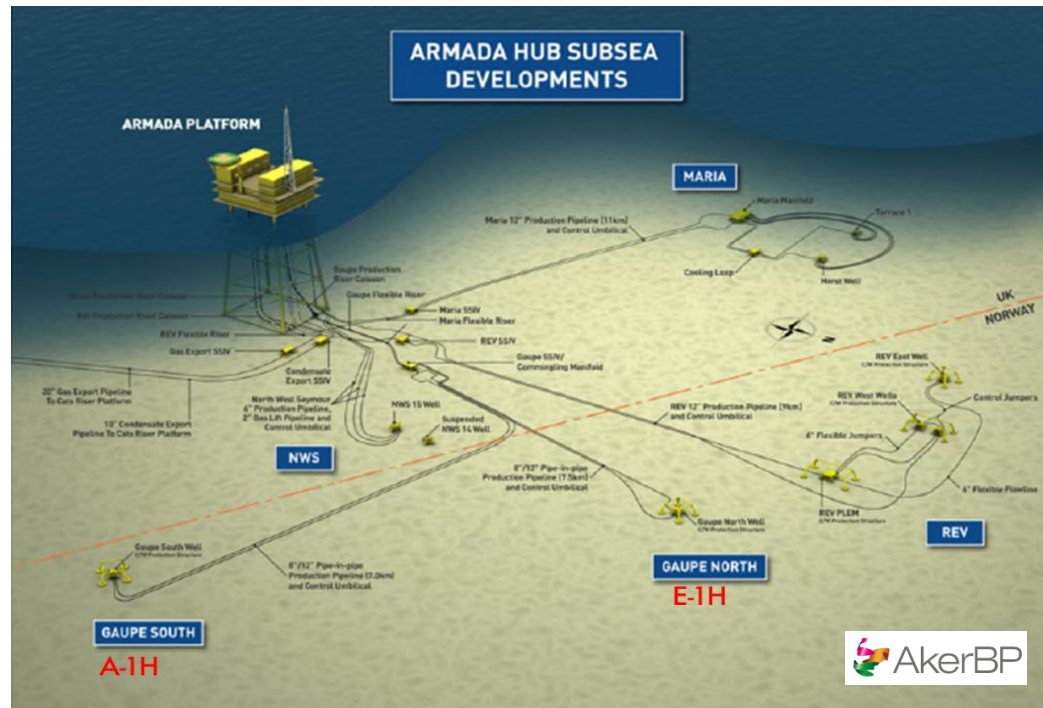
Gaupe – 2 wells (Drilled & Completed 2011)

- NPNT oil producers Southern North Sea
- “Smart Completions” with CLs thru production packers
- Suspended with Seawater
- Both wells assumed to have poor cement quality and planned to be logged with potential PWC.

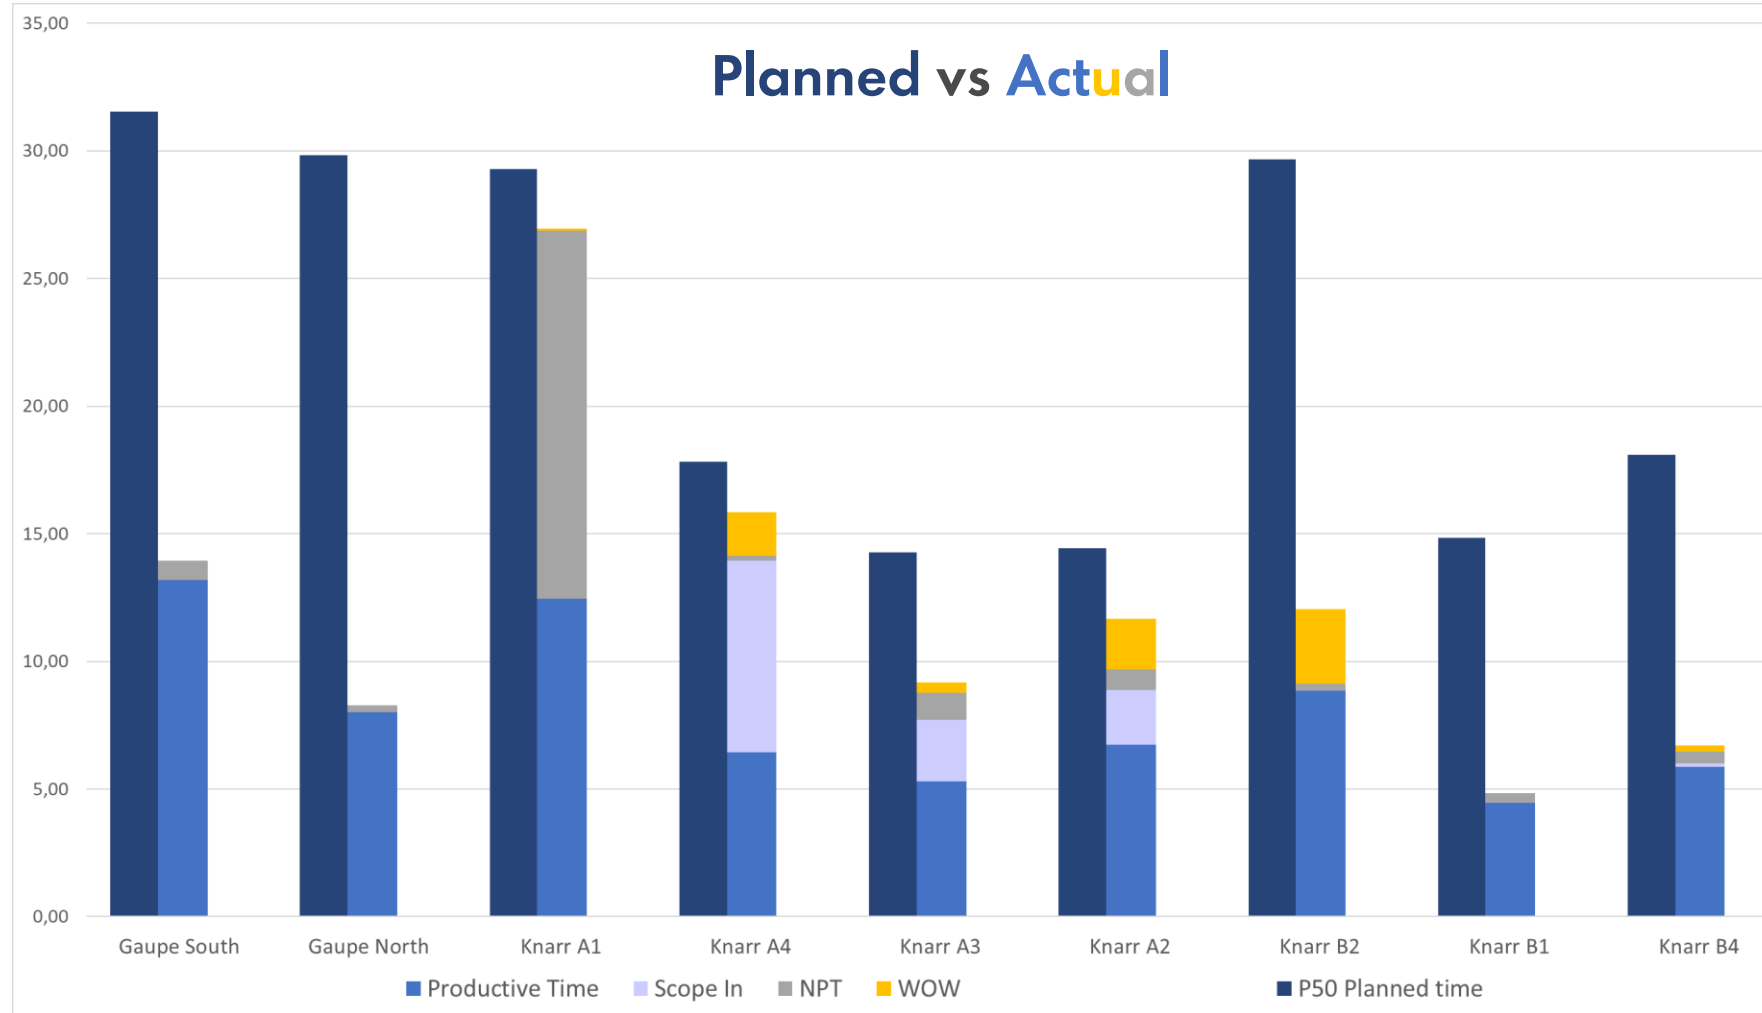
Knarr and Gaupe P&A Performance Overview

- **Planned Time:** 200 days
- **Actual Time:** 110 days
- **NPT:** 18 days (17%)
- **Scope In:** 12 days (14%)
- **WOW:** 7 days (8%)
- 35.000m of casing & tubing recovered to the rig
- 9 ea HXT's lifted off and stored on seabed

Optimized Activities	Days Saved
No PWC	40
DP and batch ops on Knarr	10
XT wet storage	7
Omit shallow plug for XT removal	4
Good weather	20
Surface scope	3
Fast tubing pulling	6

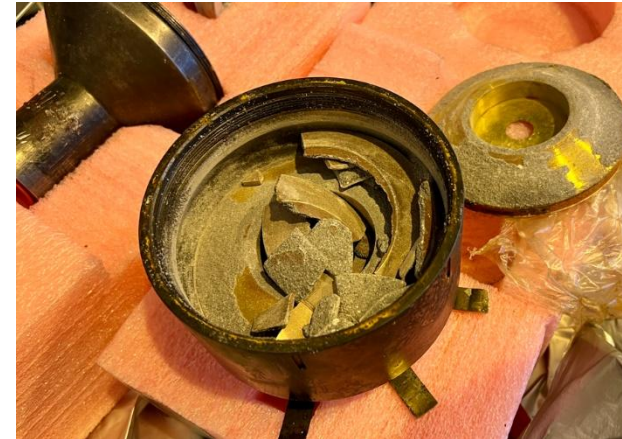
Knarr 34/3-A-2 H well

- Vision IO Camera Confirmed Dynablade cut in A-2 (LWI campaign 2023)
- However, during P&A, uncertain of cut, so assurance cut was made. On pulling tubing, original cut was found to have been successful.

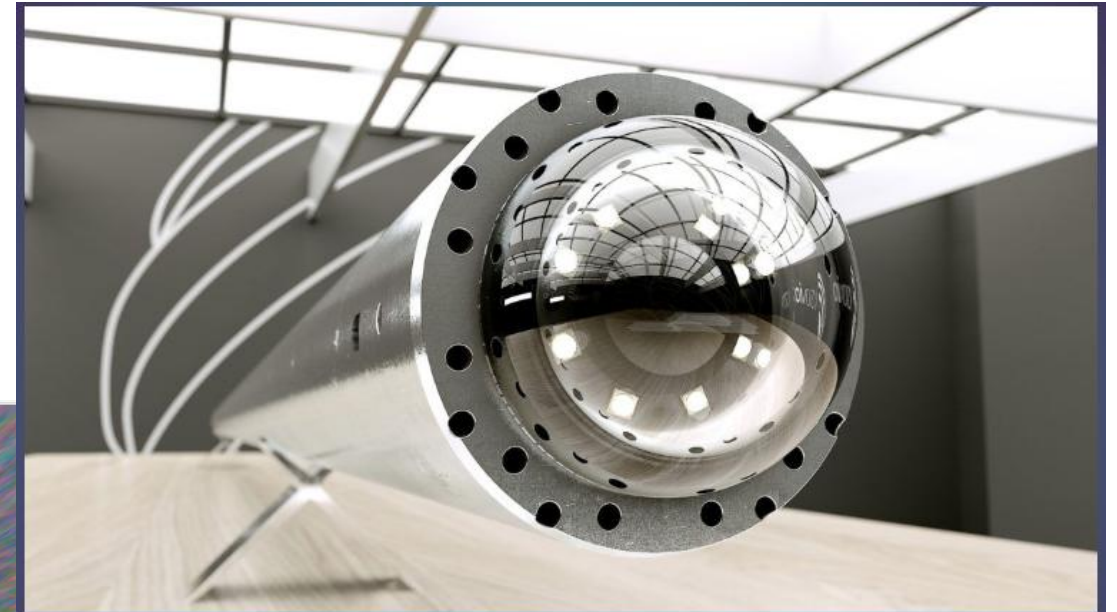
Vision IO camera

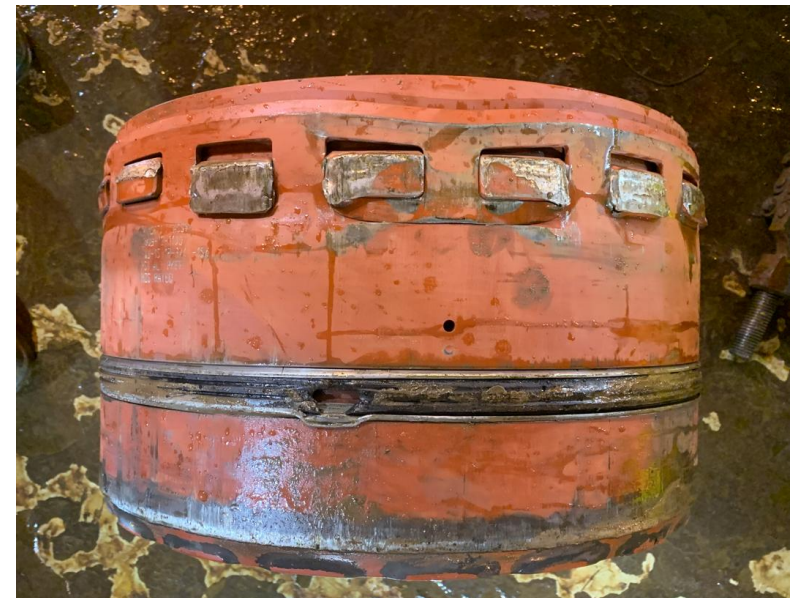
Knarr 34/3-B-4 H well

Spear prematurely set in 13 3/8" casing

- Combined BHA with casing spear and marine swivel to pull seal assembly
- Heave compensator turned off to make connection
- Spear unexpectedly engaged the 13 3/8" casing
- Rig heave of 1.2 - 1.5m applied 592 - 721 MT hookload (537 MT pull on drillstring and 512 MT overpull on casing hanger)
- Overpull caused the 13 3/8" seal assembly to yield and the cut casing and hanger released from wellhead
- The drill line on the draw works jumped causing the spooling to be incorrect and draw works inoperable.
- An initial gain of 0.35m³ was seen in the trip tank and gas expansion was seen in the riser up to 4.4m³

- Evaluate need for connection between spear and marine swivel
 - Pull S/A above BOP before engaging the spear

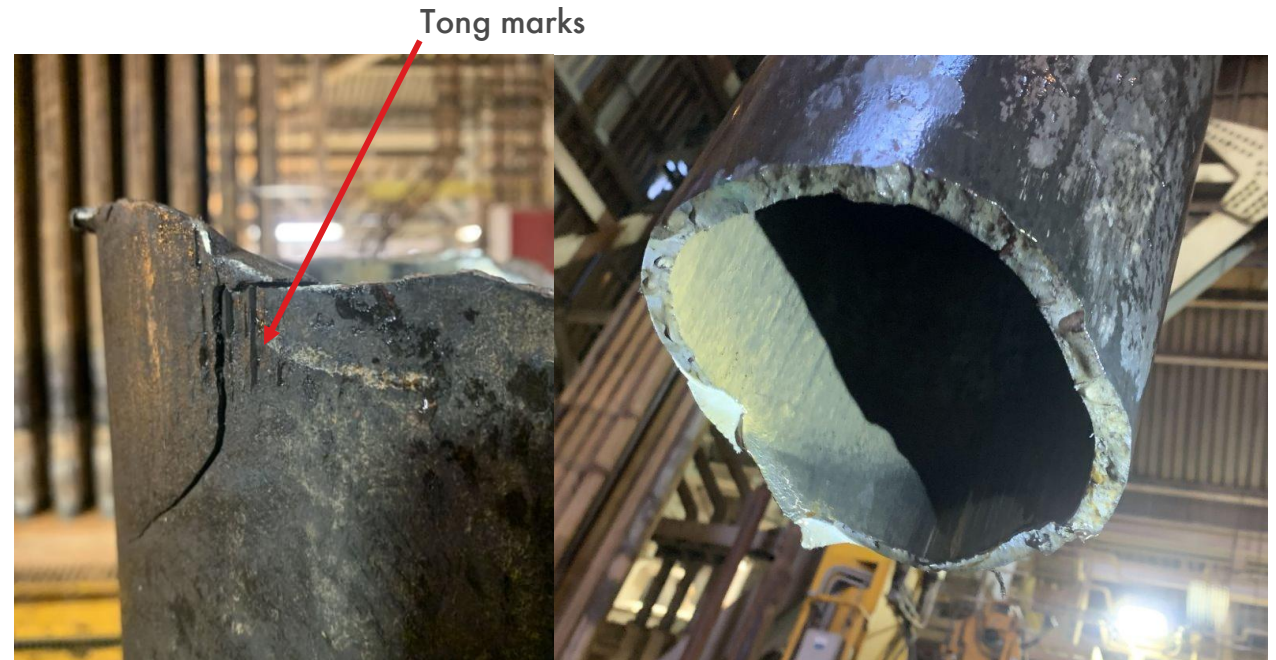
Knarr 34/3-A4 H well

Parted Tubing

- Root cause for failure still unclear
- Findings indicates that the tong mark has cold worked the 13Cr which makes it more susceptible to Stress Corrosion Cracking (SCC)
- The base oil injection into the annulus during the retrofit gas lift installation in 2019 could have introduced a lot of oxygen which caused cracking initiation
- The subsequent seawater introduction may have pushed the tubing “over the edge”

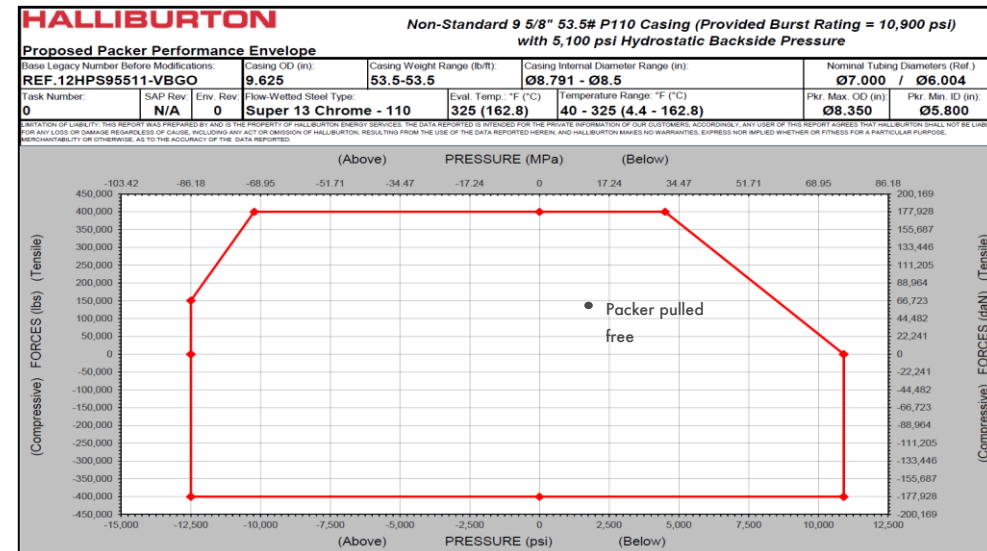
Production Packer pulled free

- Packer pulled free with 70 tons overpull when it was rated to 180 tons (40% of rating)
- CCL from DynaBlade run verified – depth reference OK
- Oxygen in seawater could corrode carbon/low alloy steel, P110 casing and also pit 13Cr material
